HISTORIC RESOURCES FOR RENT. CORNOG'S BOTTOM FARMSTEAD AND
THE RESIDENCE RENTAL PROGRAM AT RIDLEY CREEK STATE PARK

A THESIS

Historic Preservation

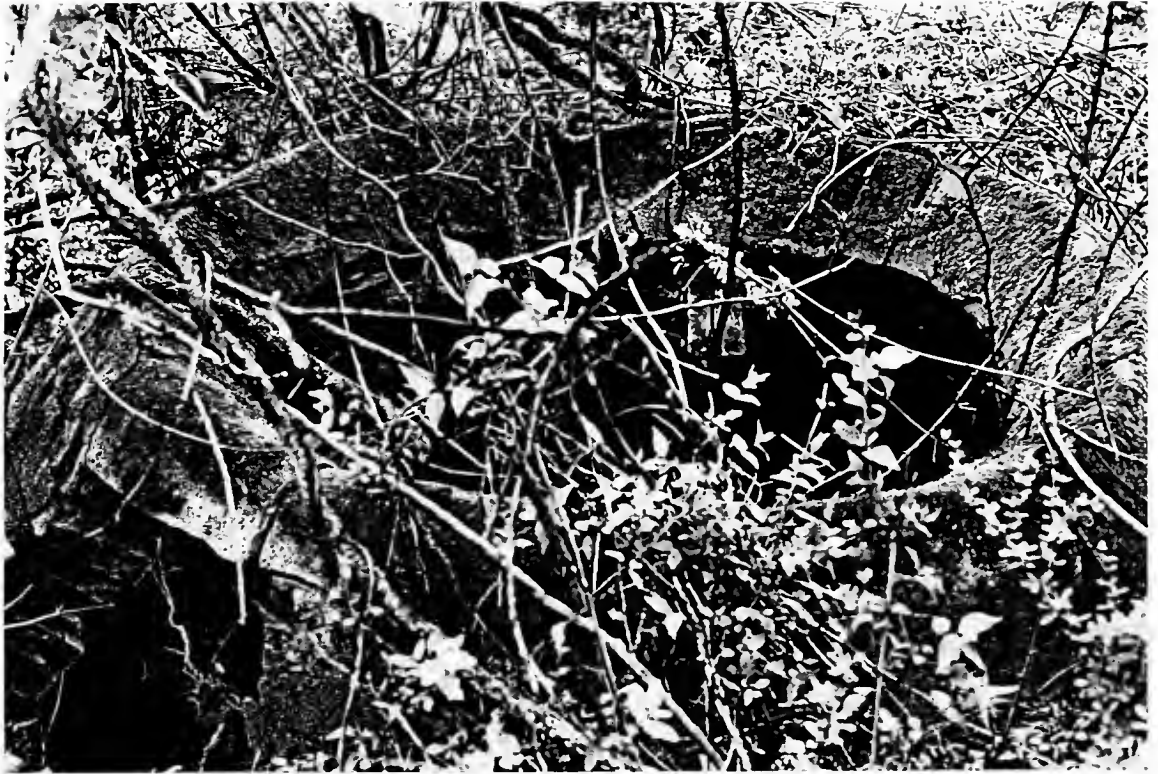
Figure 8. Cistern

Approximately 100 yards directly up the hill from the west gable end of the farmhouse is an old cistern measuring five feet in diameter and seven feet deep (Figs 8 and 9) According to Gabrielle Lanier and Bernard Herman, “cisterns found in

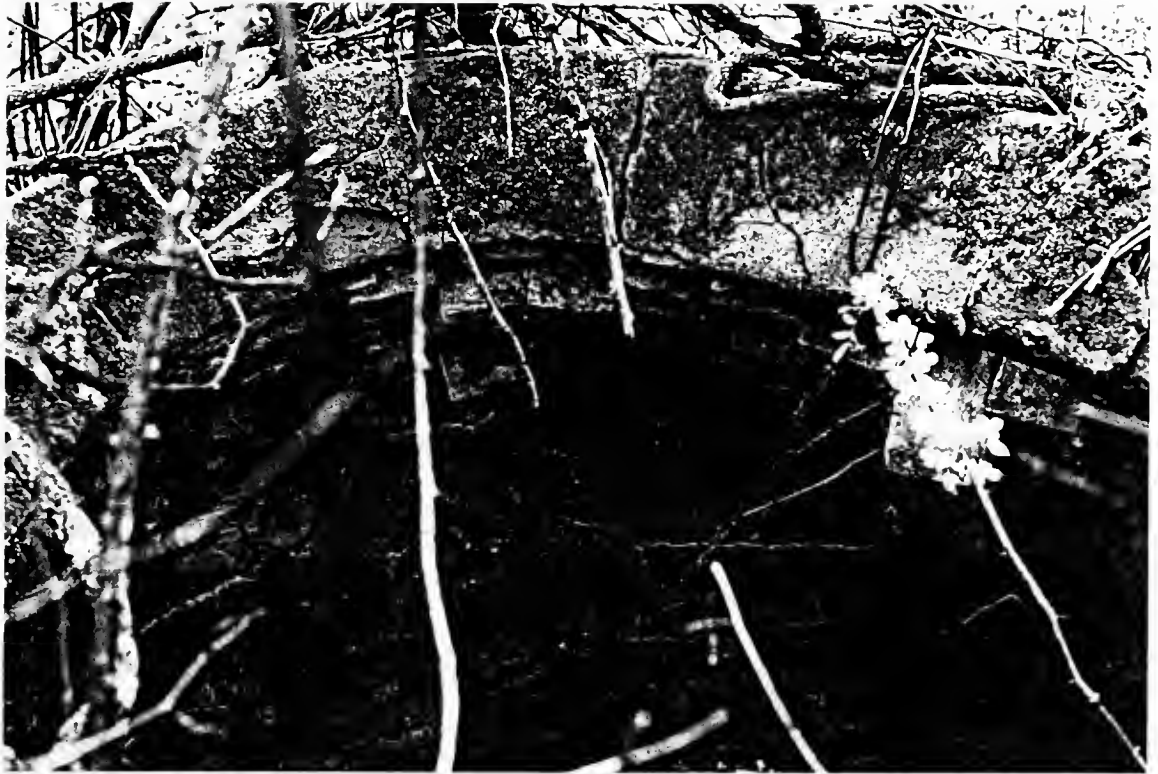
Figure 9. Detail of the cistern's interior construction

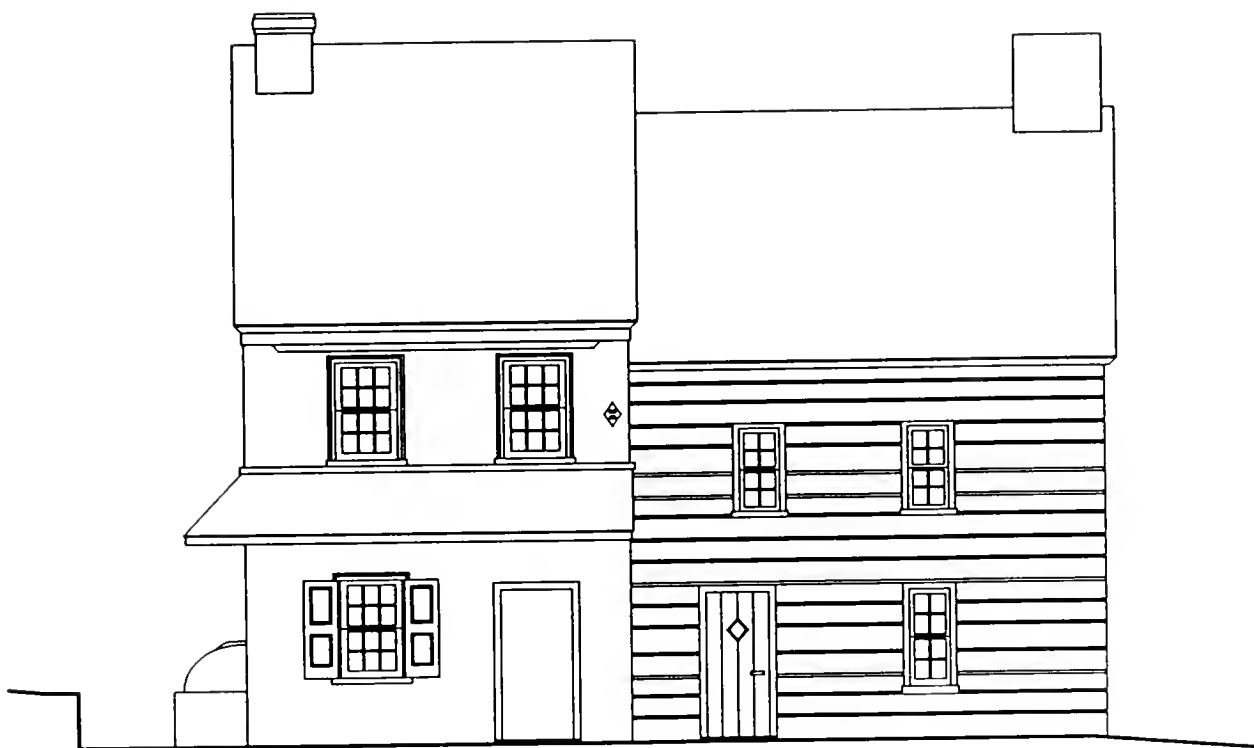
Figure 10.

SOUTH ELEVATION - CONJECTURAL
ADDITION TO EARLIER LOG HOUSE

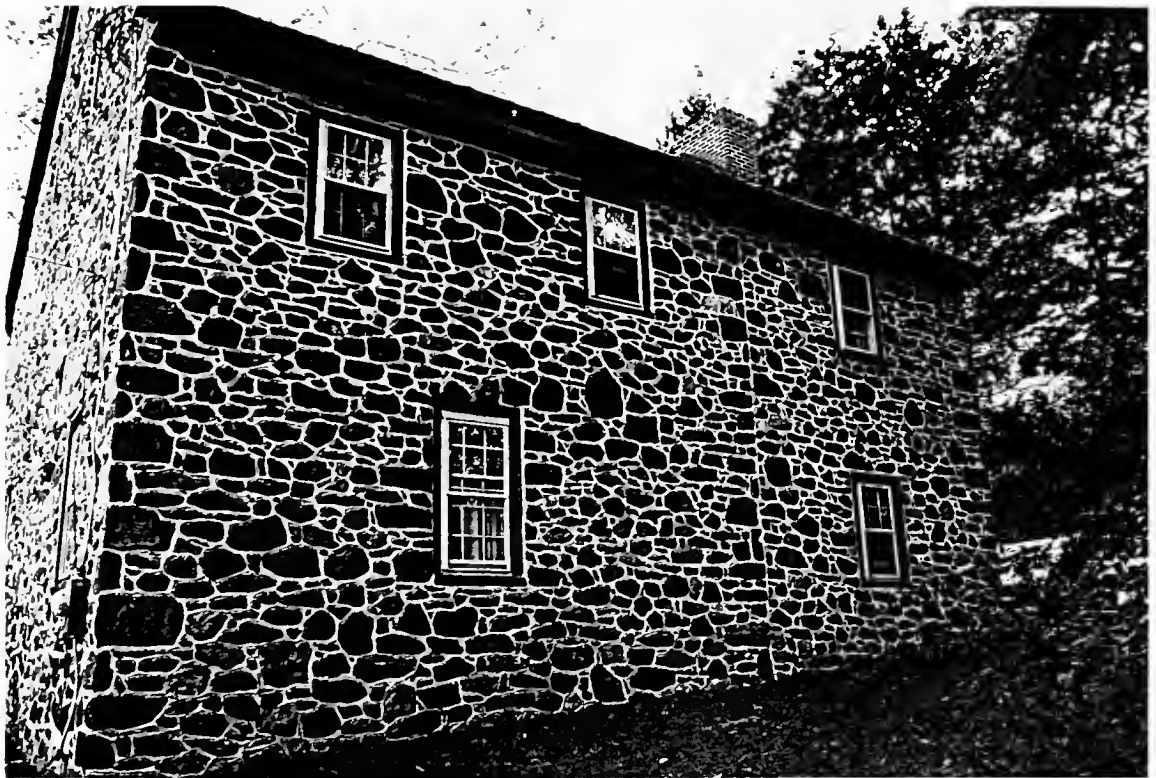
Figure 11. Farmhouse, north facade with seam

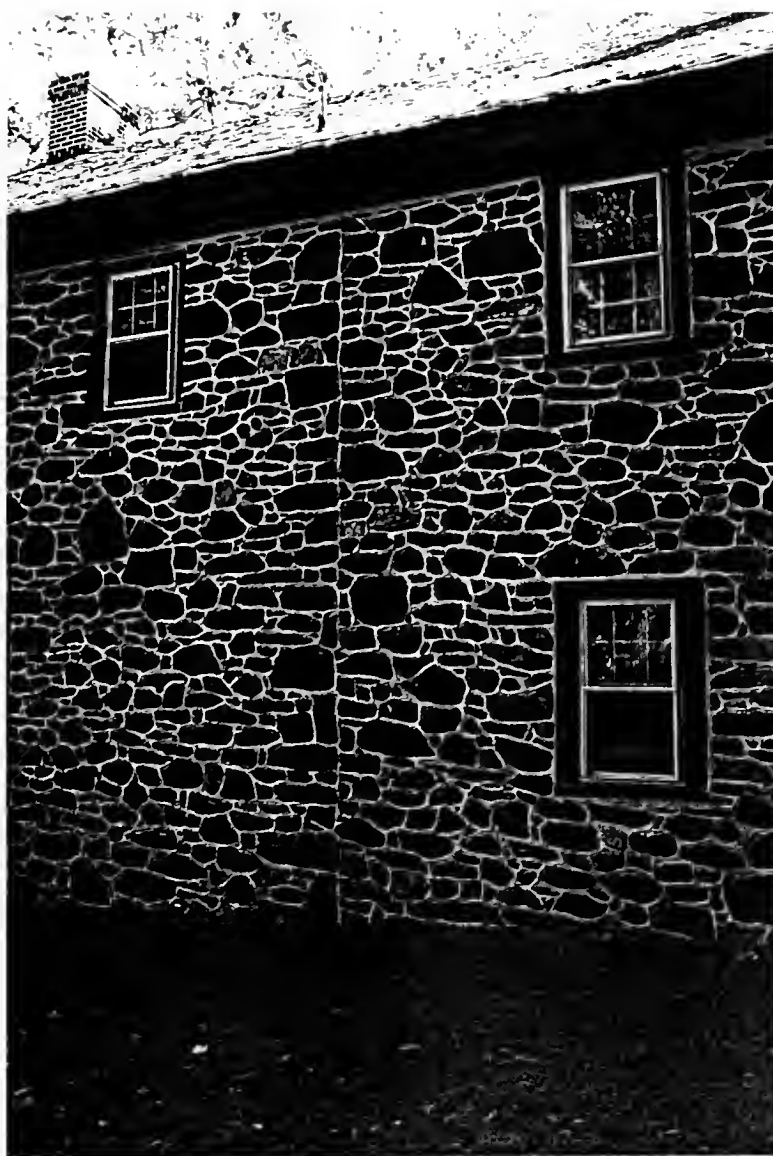
Figure 12. Farmhouse, detail of north elevation with seam

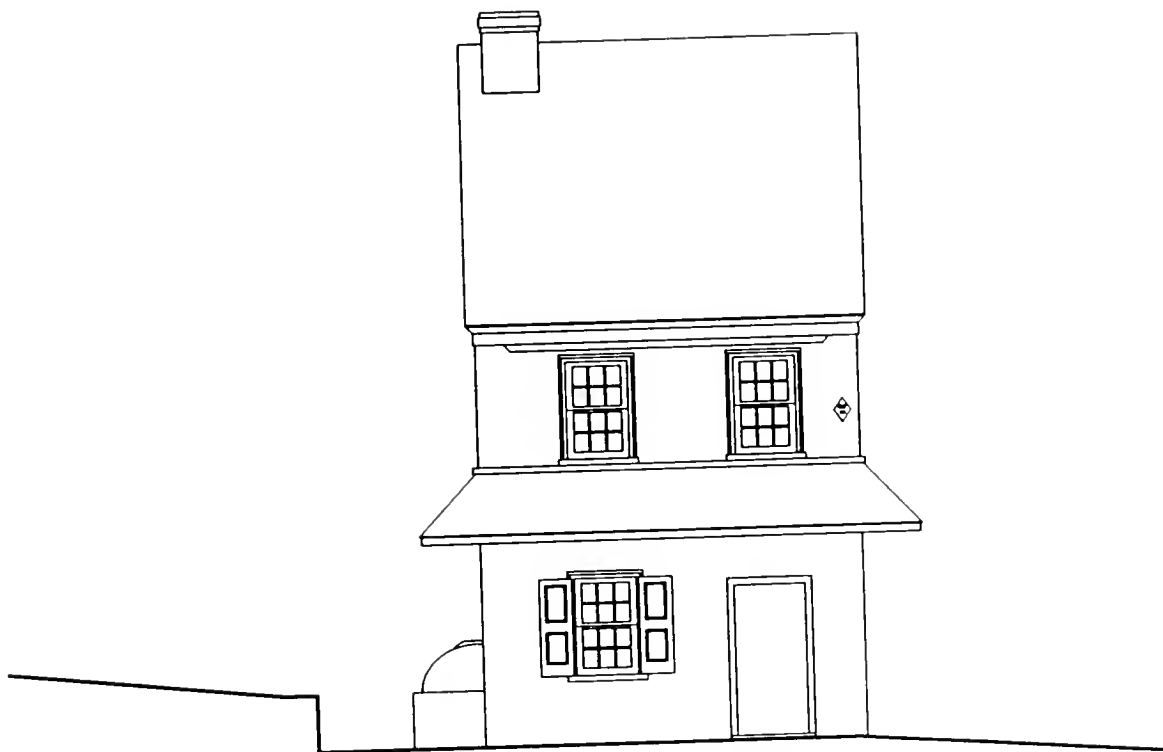
Figure 18.

SOUTH ELEVATION - CONJECTURAL

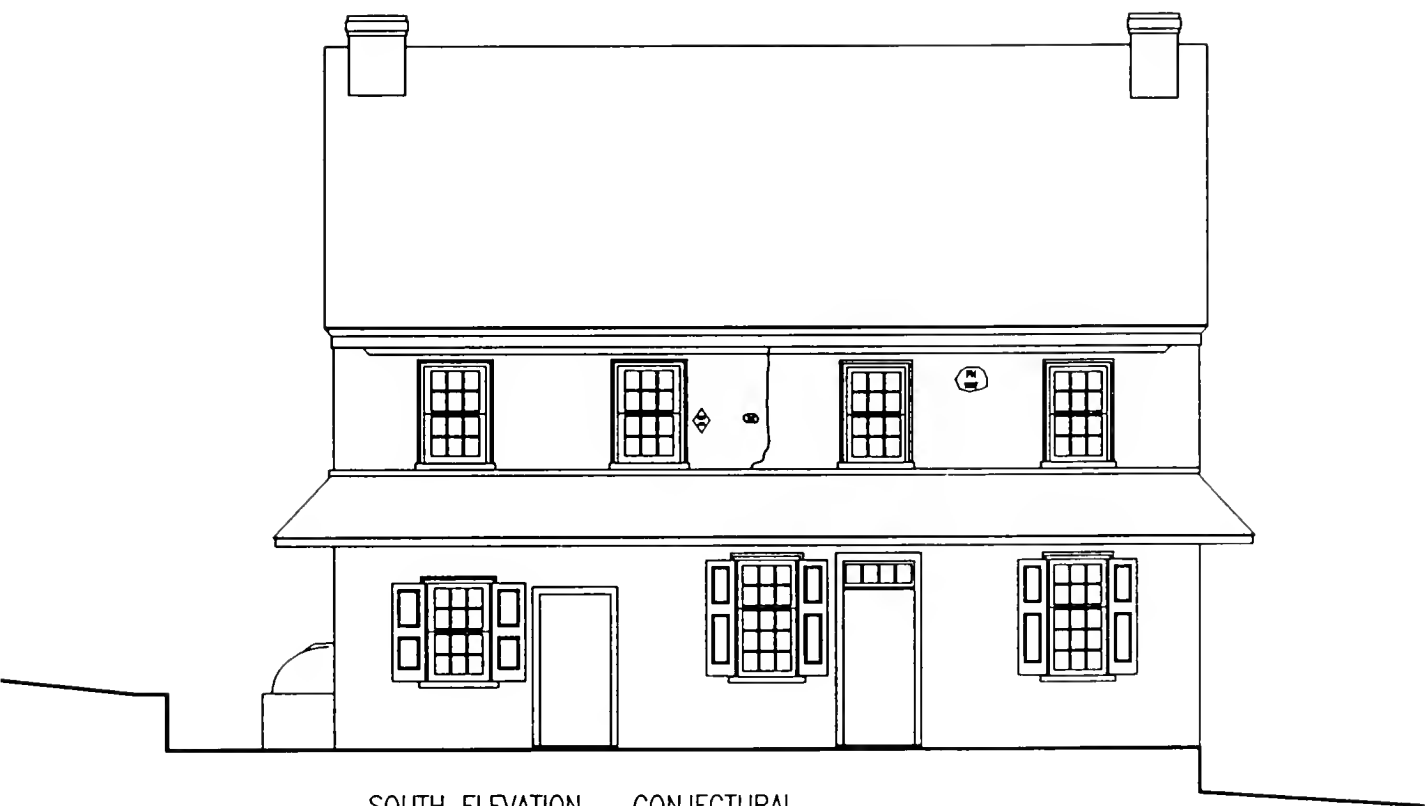
Figure 23.

SOUTH ELEVATION – CONJECTURAL

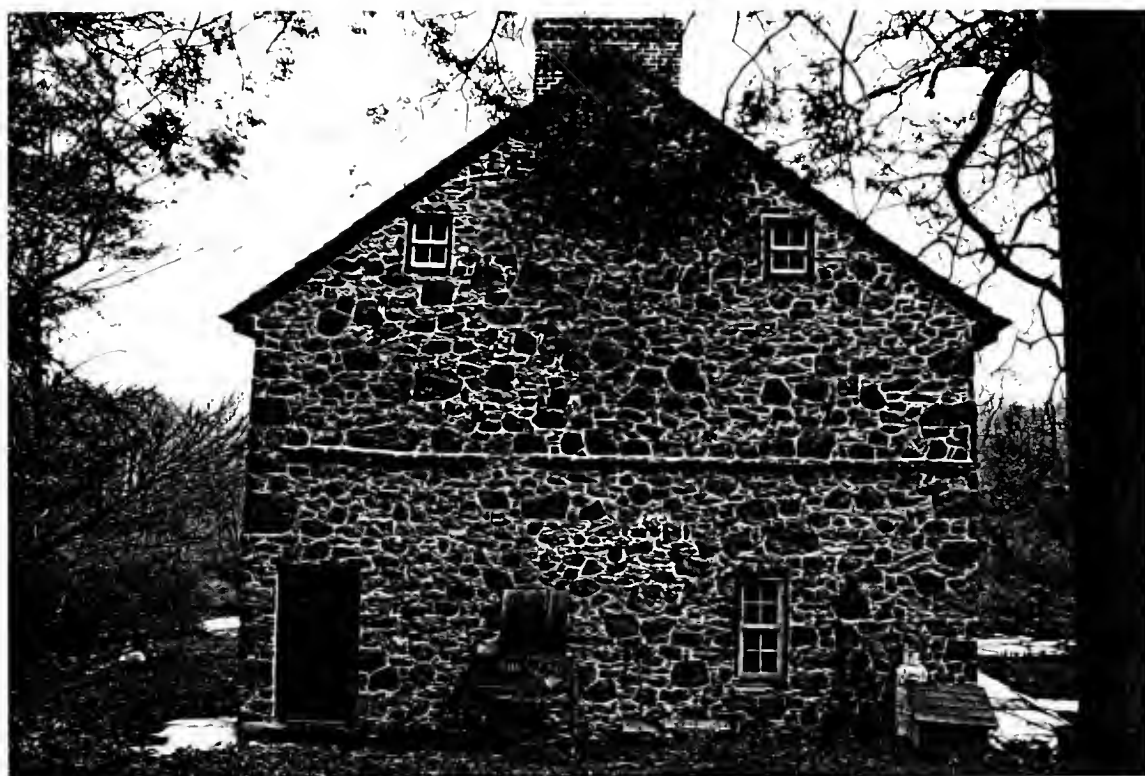
Figure 31. Farmhouse, west elevation with stone flashing course and rebuilt base of the bake oven

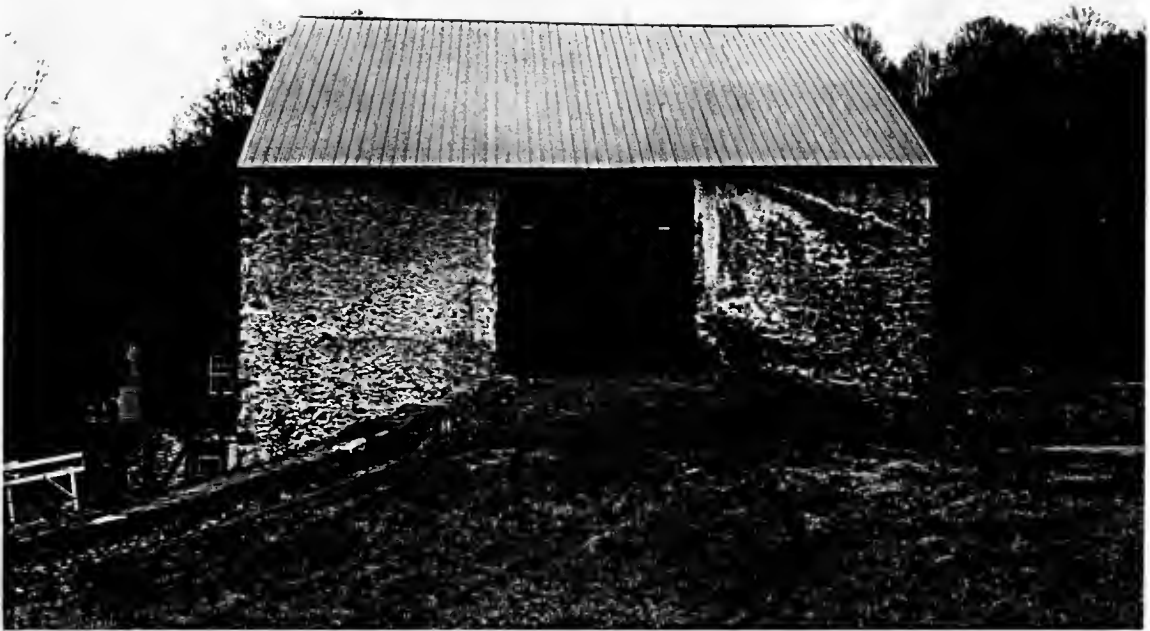
Figure 48. Barn, west facade with earthen ramp and bridge to the third level of the barn.

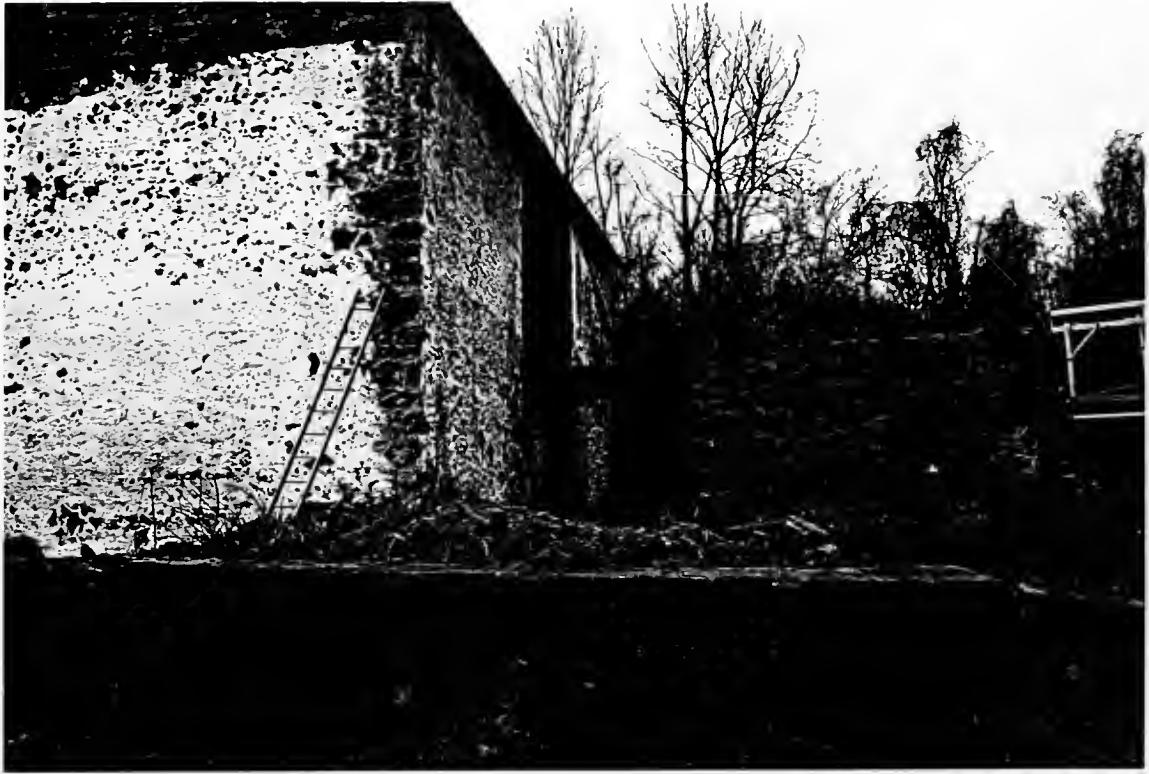
Figure 49. Barn, detail of earthen ramp and bridge to the third level of the barn.

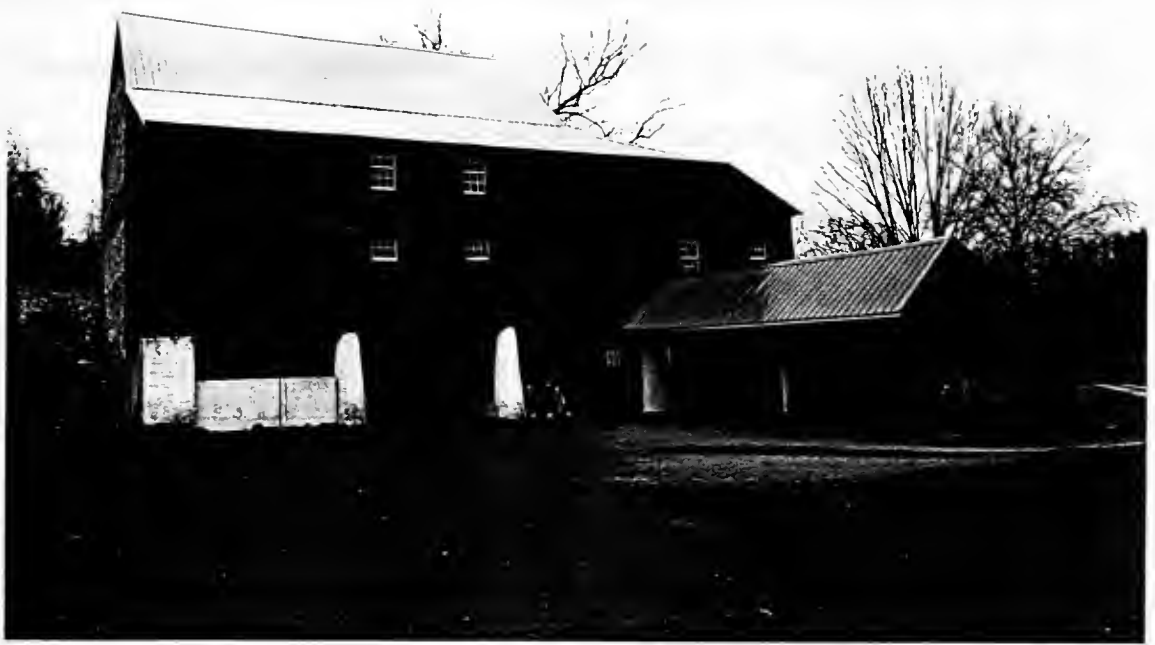
Figure 51. Barn, east facade with the cantilevered forebay addition
